LAKE CHARLES DAM

VA. NO. 01124

# PHASE I INSPECTION REPORT

## NATIONAL DAM SAFETY PROGRAM

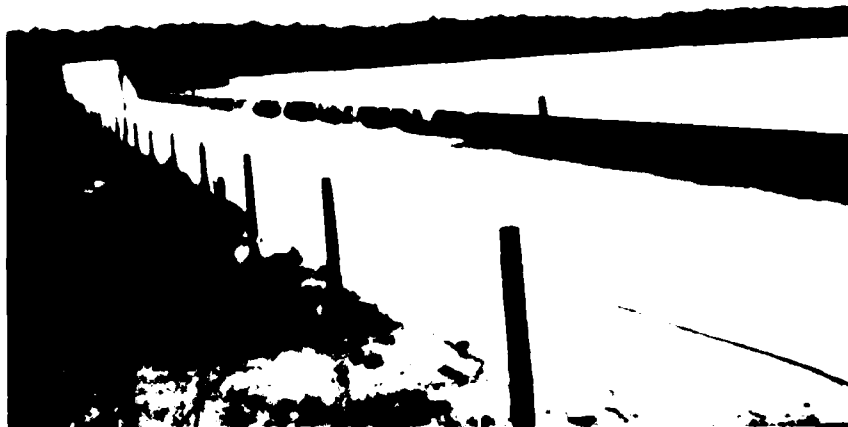
An overflow spillway and apron are located at the left abutment and consist of a 400 ft wide concrete weir with a 8 ft wide by 3 inch deep low flow notch. No signs of deterioration were noted and the concrete appeared to be in good condition. There was no separate approach channel to the spillway. The reservoir area upstream of the weir was riprap lined and appeared to be in good condition. The discharge channel is approximately 300 ft wide and slopes at about 7.5 percent. Immediately downstream from the weir, the discharge channel is occupied by the access road which crosses the dam crest. The road is concrete through the spillway area and bordered by a cable guardrail along the downstream edge. The discharge channel is lined with stone riprap and grouted along the center portion below the roadway. Evidence of severe erosion during Hurricane Camille is still visible in the lower reaches of the discharge area. It was reported that 11 ft deep gullies were carved into the discharge channel below the concrete section. These have been backfilled with riprap and concrete slurry and appeared stable.

Photograph No. 1 - Spillway  
Note Access Road Across Spillway

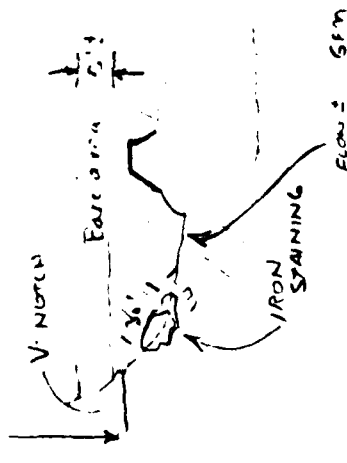
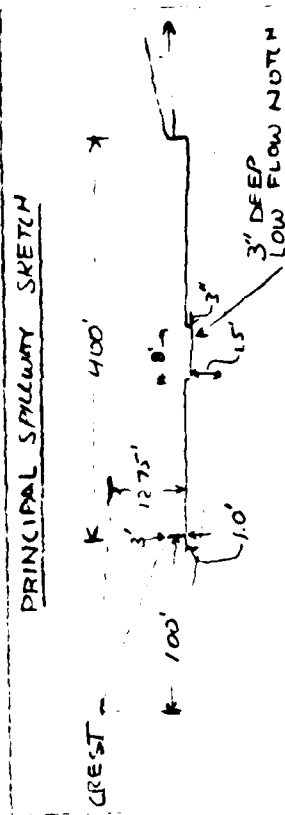
FIELD SKETCH LAKE CAROLINE DAM

VISUAL EXAMINATION OF	OBSERVATIONS	REMARKS AND RECOMMENDATIONS
CONTROL SECTIONS	Principal spillway consists of a 400 ft wide concrete wier with a 7 ft wide x 3" deep low flow notch. See Field Sketch, Sheet 1.	Combined principal-emergency spillway in good condition.
APPROACH CHANNEL	No separate approach channel. Area upstream of wier is riprap lined and in good condition.	-
DISCHARGE CHANNEL	The discharge channel is approximately 300 ft wide and slopes at about 7.5%. Immediately below the wier the discharge channel is connected and bordered by a cable guard rail along the downstream edge. This area serves as part of the road crossing the dam. Just downstream from the roadway the discharge channel is covered with riprap. The discharge channel area downstream from the concrete section was severely eroded in 1969 during hurricane Camille. 11 ft deep gullies eroded in the channel areas during the storm were backfilled with riprap and concrete slurry. Evidence of severe erosion during the storm is still visible in the lower reaches of the discharge area. The area appeared stable.	This information was received from Mr. Miller during the inspection.
